Defect Report

Make: RANS Coyote
Model: S6S
TTIS: 860 hours
Reporter: Stan Hyde
Date: 4 Martch 2014

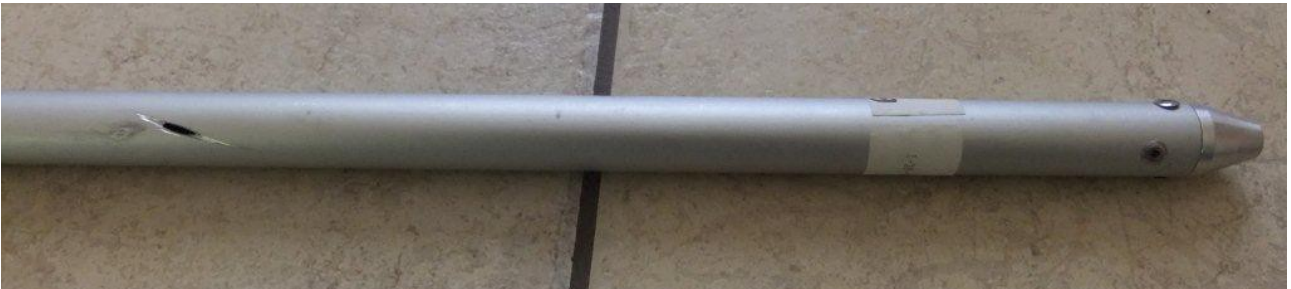
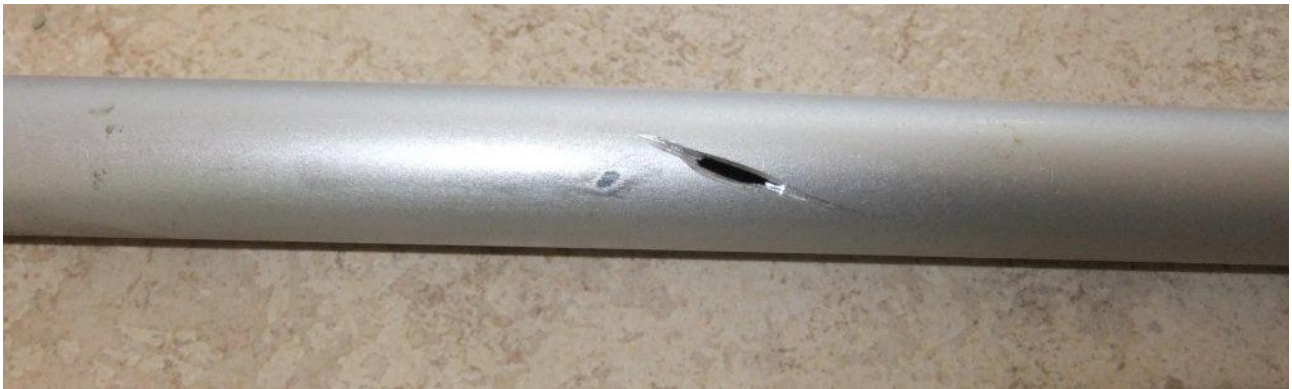
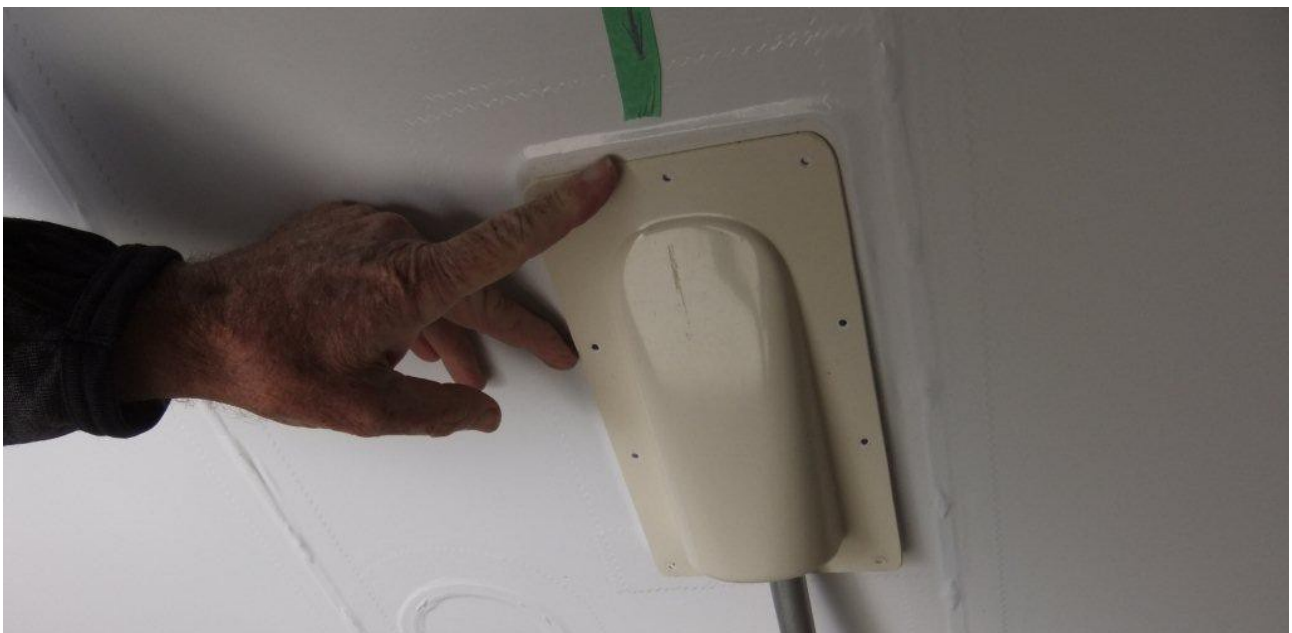
Both aileron push-rod tubes damaged due to wing cover plate screws rubbing on tubes.

One has worn right through tube.

It is easy to inspect both ends of these push-rods but overlook the middle.

When worn right through the tube, the screw could then lock the tube from full and free movement.

Inspection of another S6S revealed the same defect.

Removed and replaced push-rods

Left the middle cover retaining screw out.

1. Remove cover and inspect before further flight.
2. Replace any rods with evidence of wear.
3. Do not fit the middle cover retaining screw- it is well retained with the remaining screws.
