Microlight Defect Report

DRP No: 1477891994

Microlight type/model Skyfox Gazelle

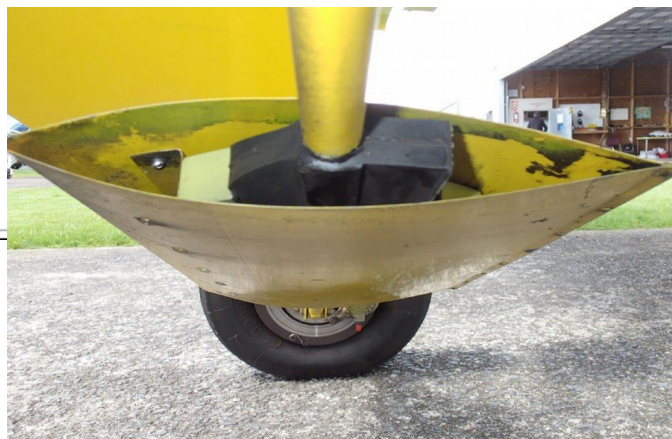
New undercarriage suspension struts were ordered and fitted in April 2016 .These we supplied from Coastal Aviation in Queensland Australia.They have only been in service for six months and have failed.(Found collapse on the 27th October)The shock part is vulcanized rubber and it has not bonded to the steel part of the strut causing the suspension to collapse.(Fault in manufacturing process)

Lucky for Feilding Flying Club members that the struts collapse while the aircraft was parked in the hangar and not in use on the runway.Aircraft is now not usable.Grounded until further notice.

Aircraft was immediately grounded and Coast Aviation notified.They seem to be aware that there was an issue with vulcanizing and are working on a solution.
