Microlight Incident Report

IRP No: 1481572456

Microlight type/model Avid Flyer C model/ Mk4

Place of incident Leo Johns airstrip at Mata

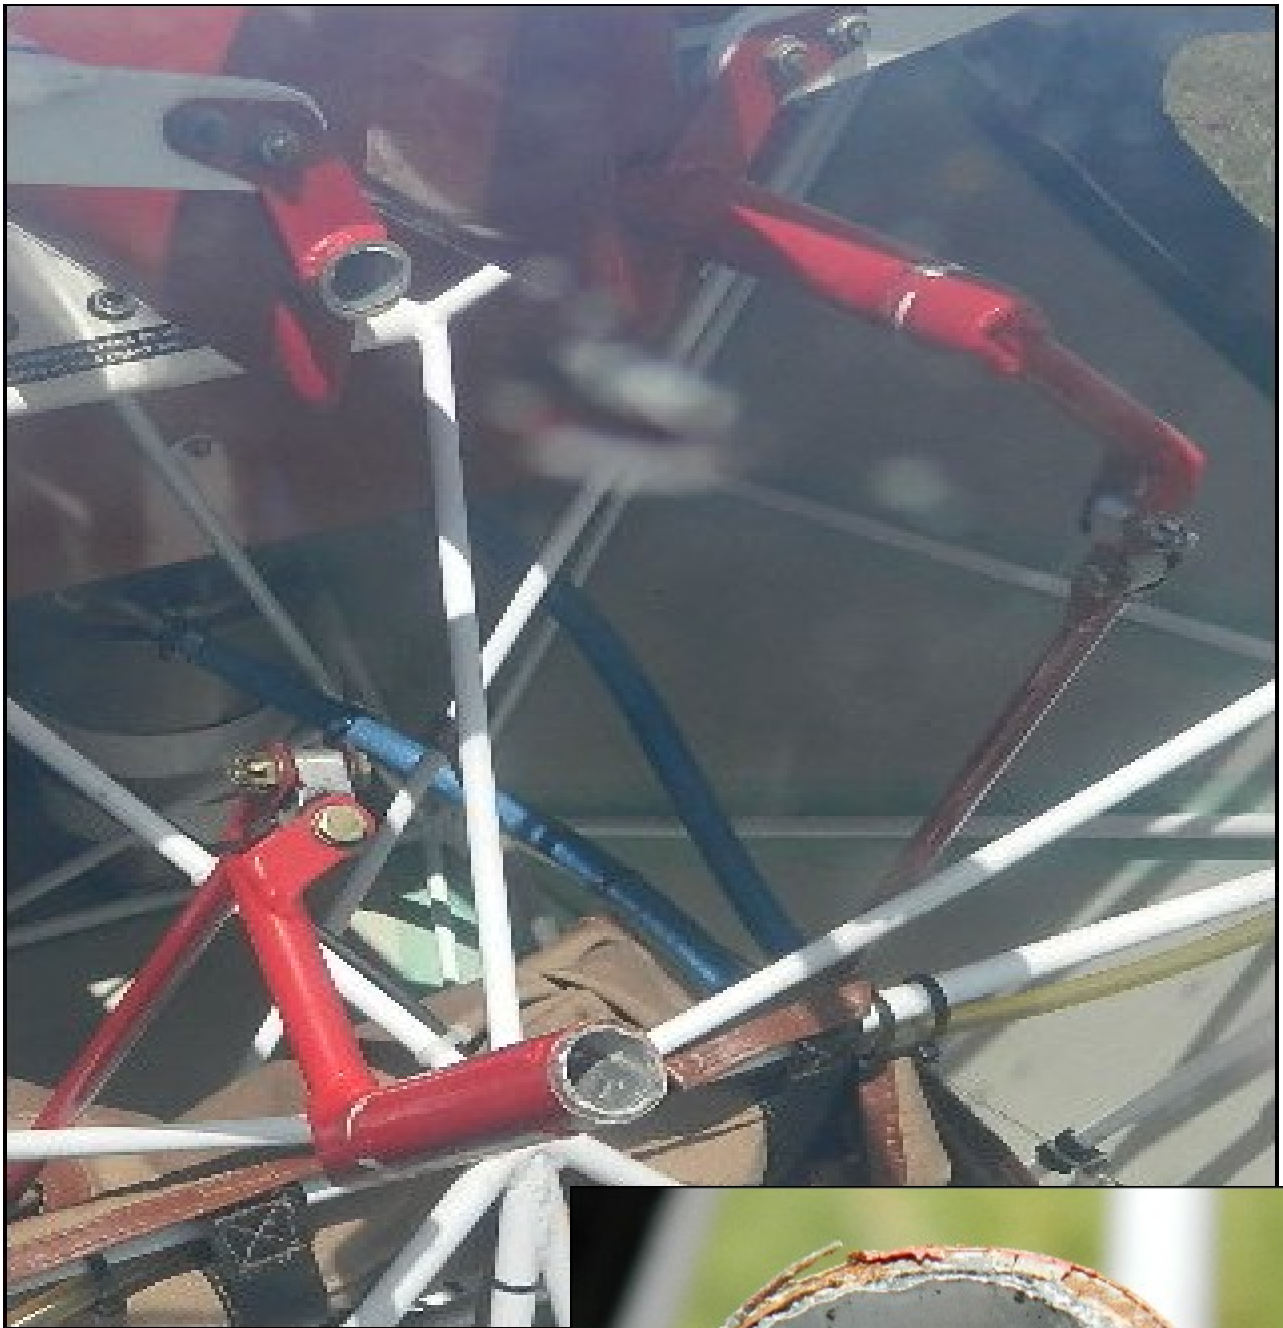
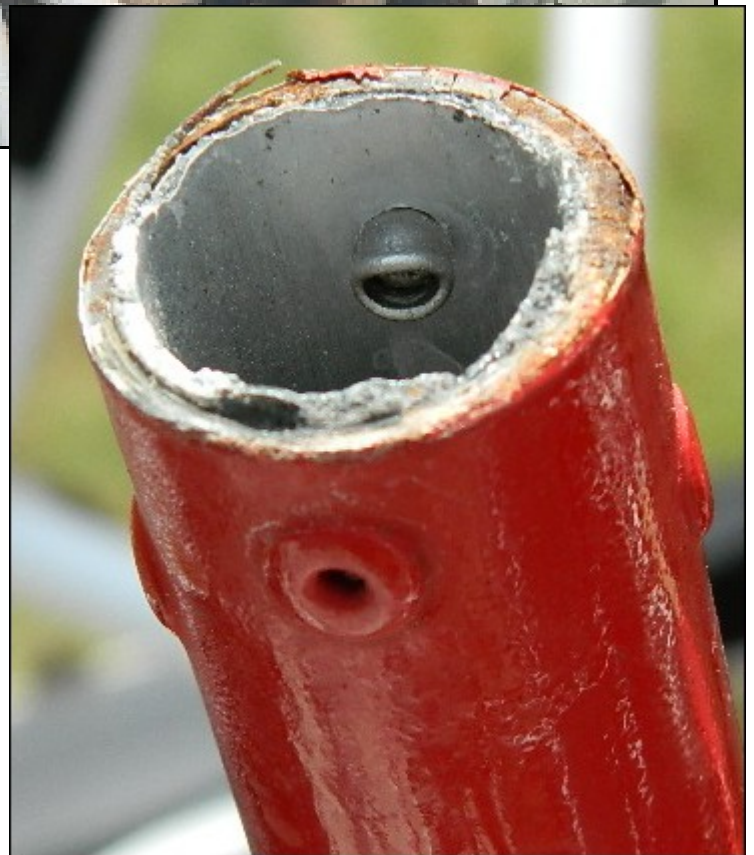
I was doing some forced landing practise, coming in to the strip at an angle from the RH side. I allowed the aircraft to drift too far towards the LH side of the strip which required a moderate turn to the right at very low level to line up with the runway. We came around in the turn but instead of levelling out we just stayed in the turn until we stalled and crash landed. A subsequent inspection of the aircraft revealed the RH control completely snapped off the end of the flaperon. As the R

Serious concern for all Avids. These flaperons have a central aluminium spar tube that all the hinges turn on. This tube sticks out the inboard end where a 4130 steel sleeve and bellcrank is riveted on to the aluminium tube. The scary part is you cannot see any part of that inner aluminium tube, it is completely covered over by the bearings and steel sleeve, so there is no way of knowing that it is cracked or corroding.

Still debating how to fix and strengthen that spar tube. CAA, SAC and the Avid Forum in USA have all been notified.

Immediate inspection of all Avid flaperons but I am not sure how these tubes can be adequately inspected.
